PHASE I ENVIRONMENTAL SITE ASSESSMENT

TELEGRAPH HILL SCORIA PIT (TRACT 37) ST. PAUL ISLAND, ALASKA

October 20, 2005

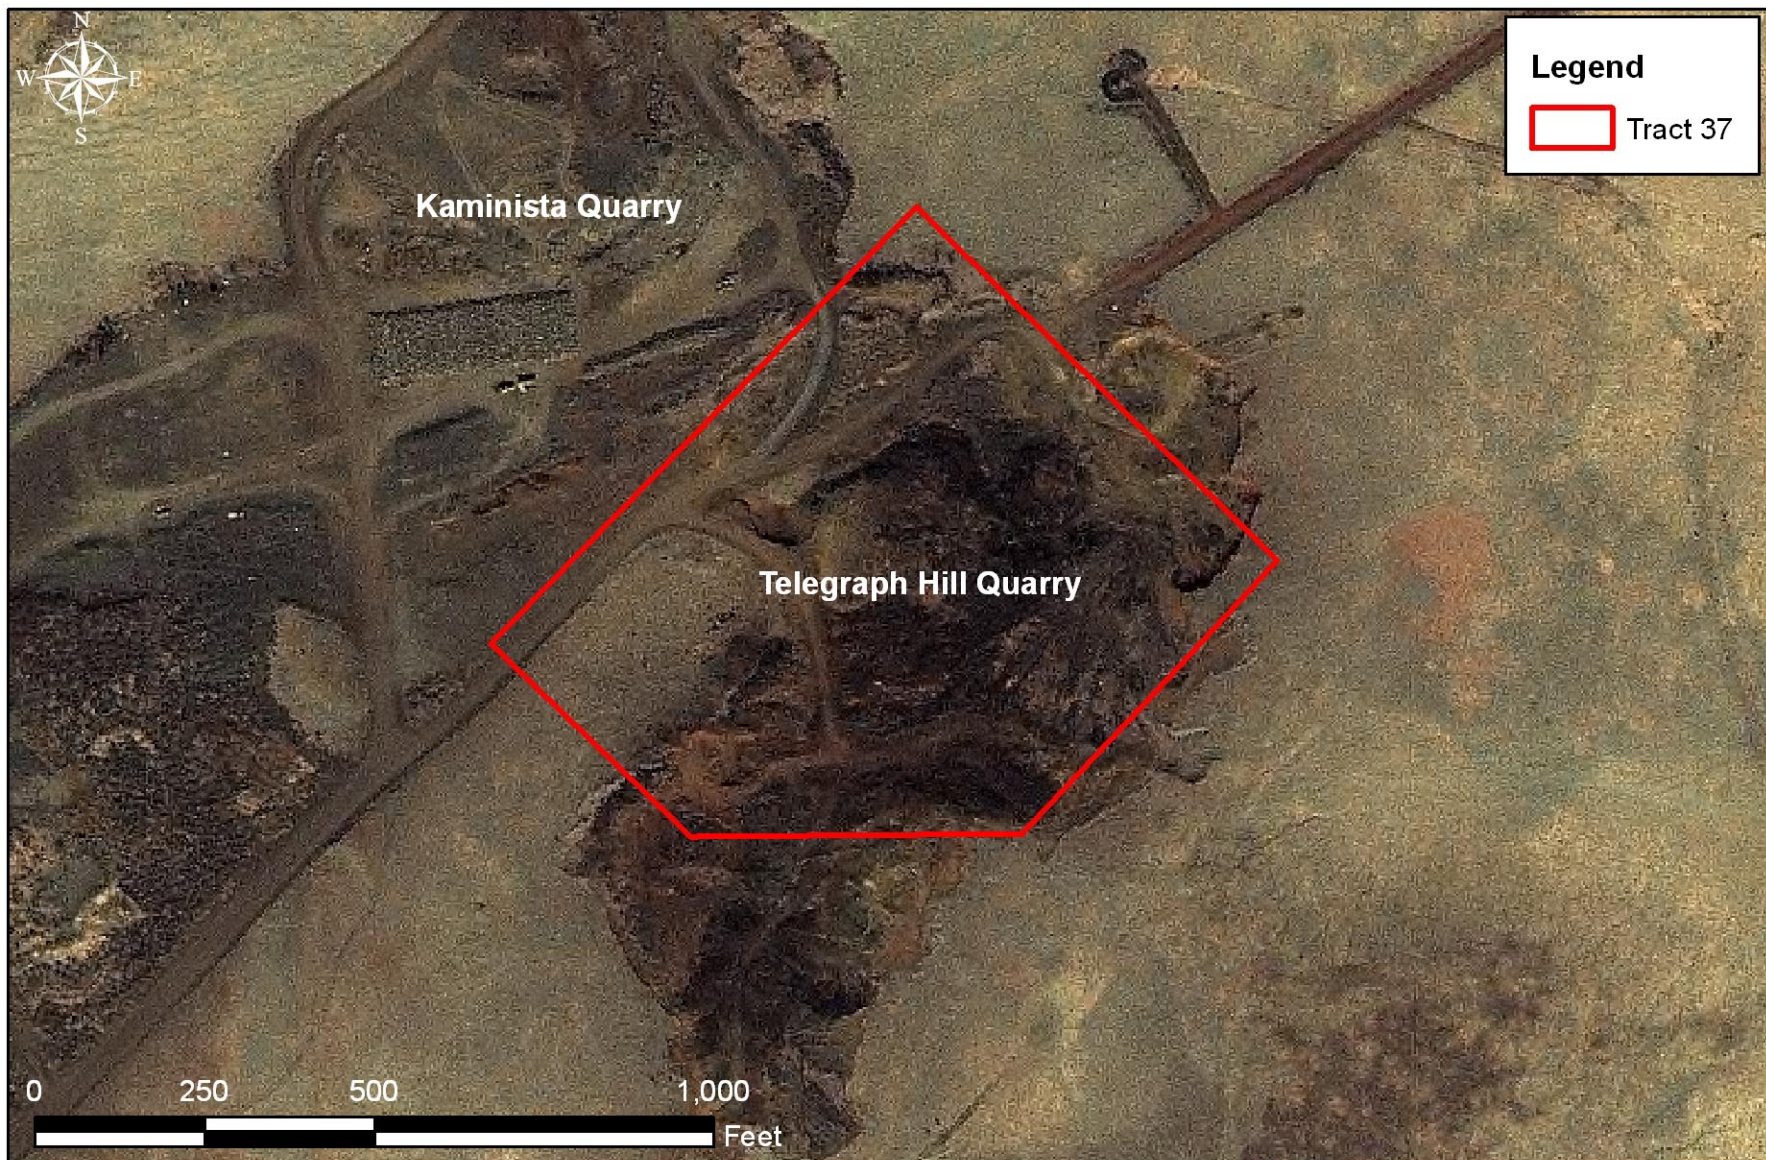
2

Subject Property
Telegraph Hill Quarry
St. Paul Island, Alaska

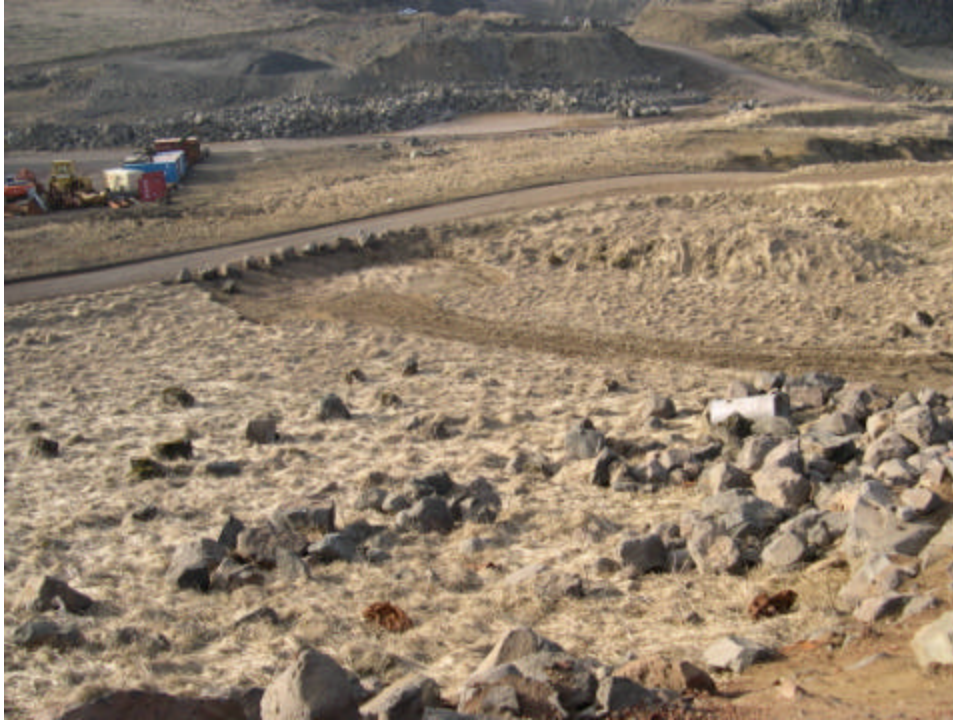
Photo 1. Telegraph Hill Quarry (Tract 37). Looking From Western side of subject property to North. NOAA. May 2005.

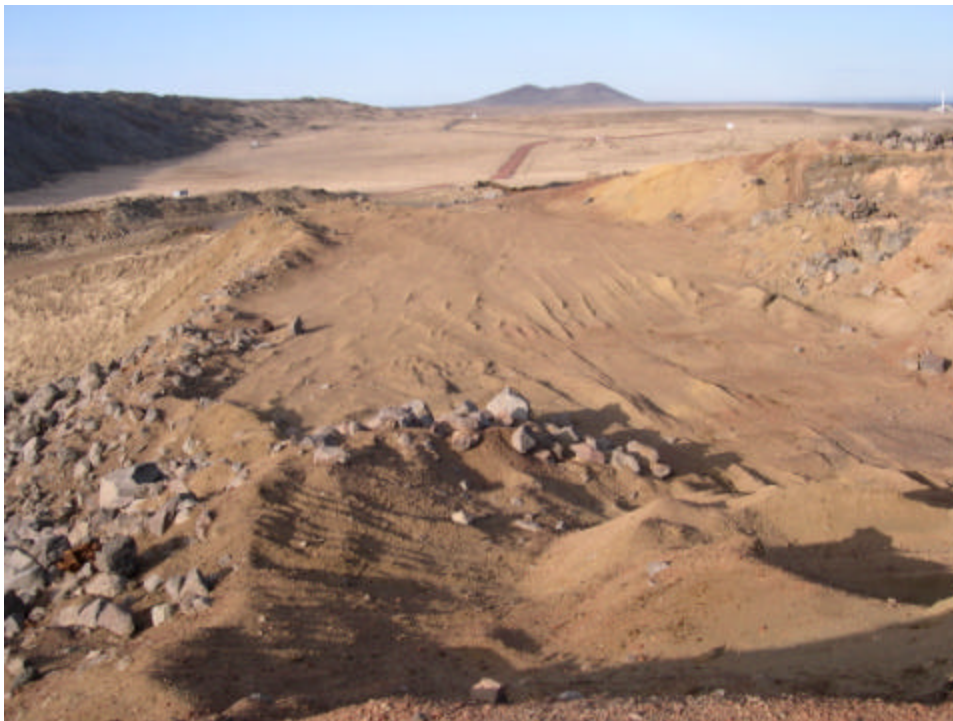
Photo 2. Telegraph Hill Quarry (Tract 37). Looking From Central portion of subject property to Northwest. NOAA. May 2005.

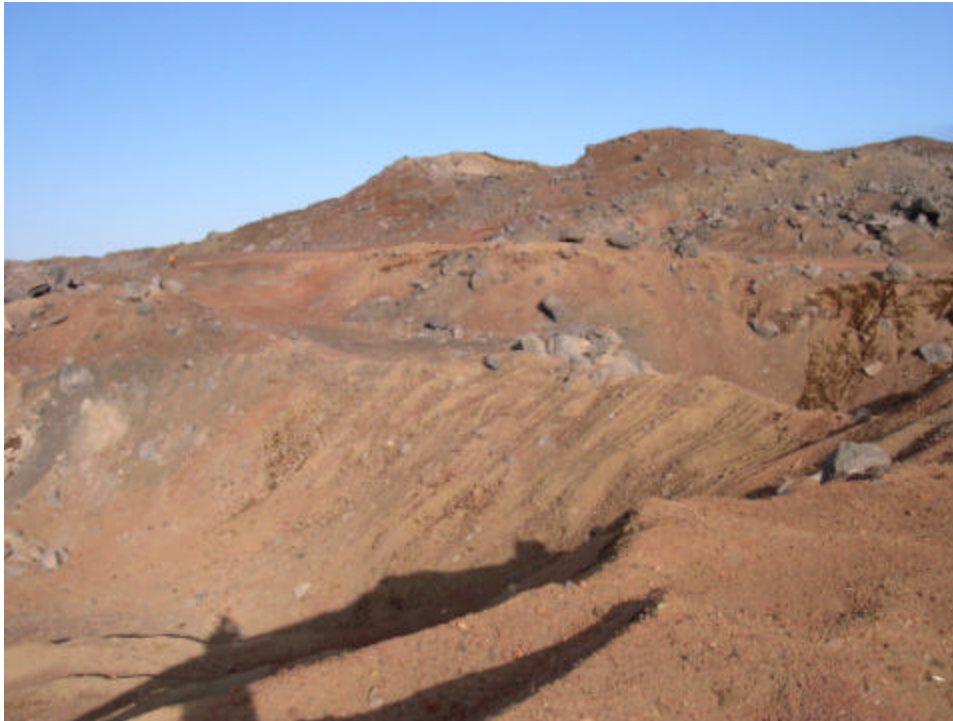
Photo 3. Telegraph Hill Quarry (Tract 37). Looking From Southern portion of subject property to Southeast. NOAA. May 2005.

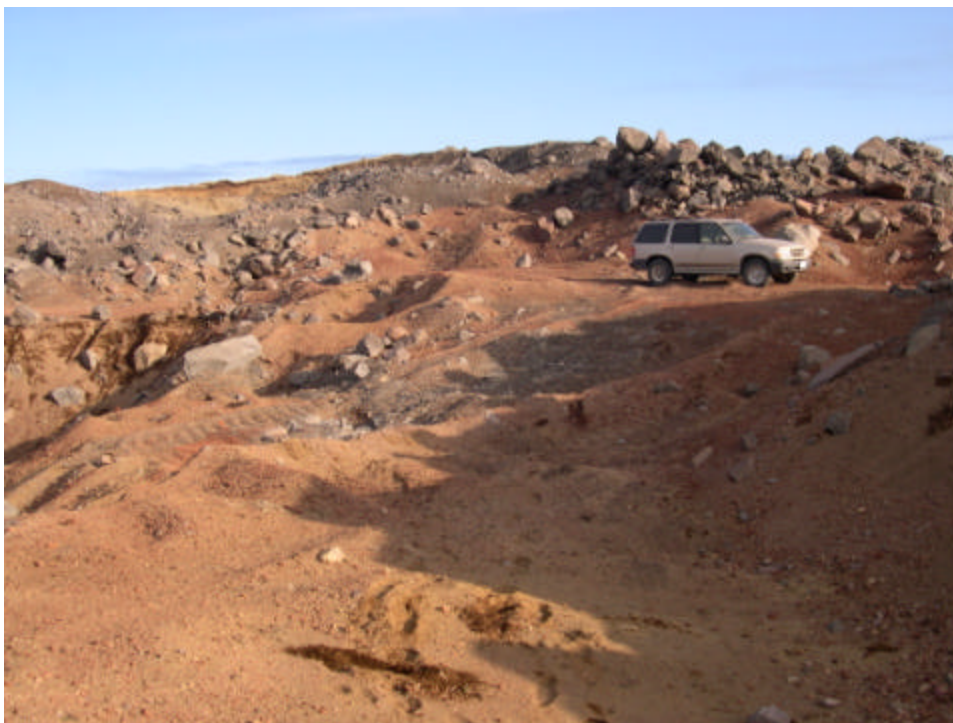
Photo 4. Telegraph Hill Quarry (Tract 37). Looking Central portion of subject property to Southeast. NOAA. May 2005.

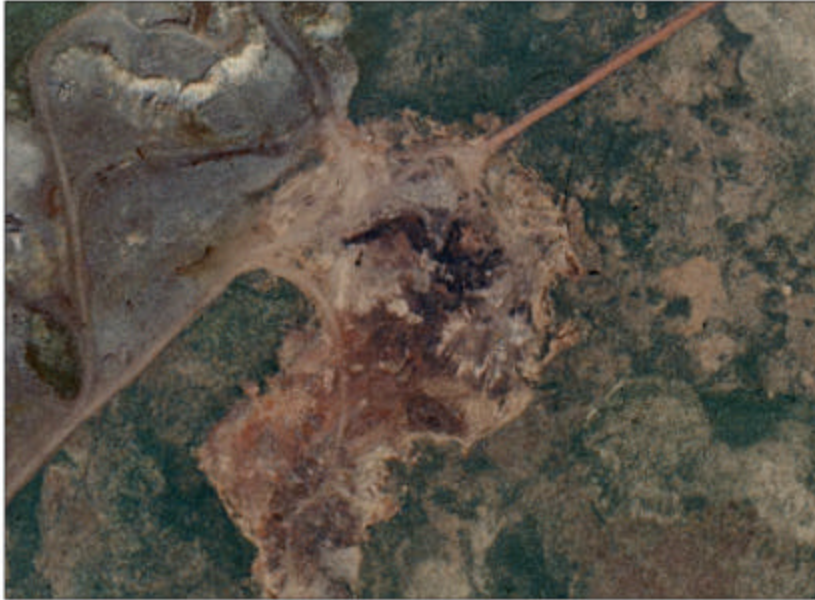
Photo 5 Telegraph Hill Quarry (Tract 37). Quadrangle Aerial Photograph. Note Image is Oriented with Due North at 12 O'Clock. U.S. Geological Survey. 1993.

-
- **2000.** This Aeromap aerial photograph shows the subject property at roughly the same state as the 2001 IKONOS satellite image. No features of interest are apparent.
 - **1993.** This U.S. Geological Survey Quadrangle aerial photograph shows the subject property at roughly the same state as the 2001 IKONOS satellite image. No features of interest are apparent.

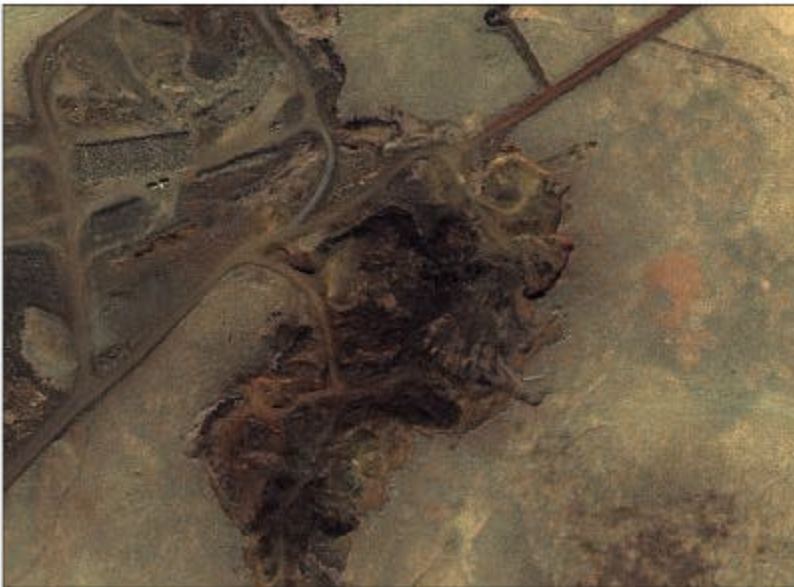
Photo 6. Telegraph Hill Quarry (Tract 37). IKONOS Satellite Image. Note Image is Oriented with Due North at 12 O'Clock. Space Imaging, Inc. 2001.

- **2001.** This IKONOS satellite photograph shows the subject property similar to its current physical condition. No features of interest are apparent.

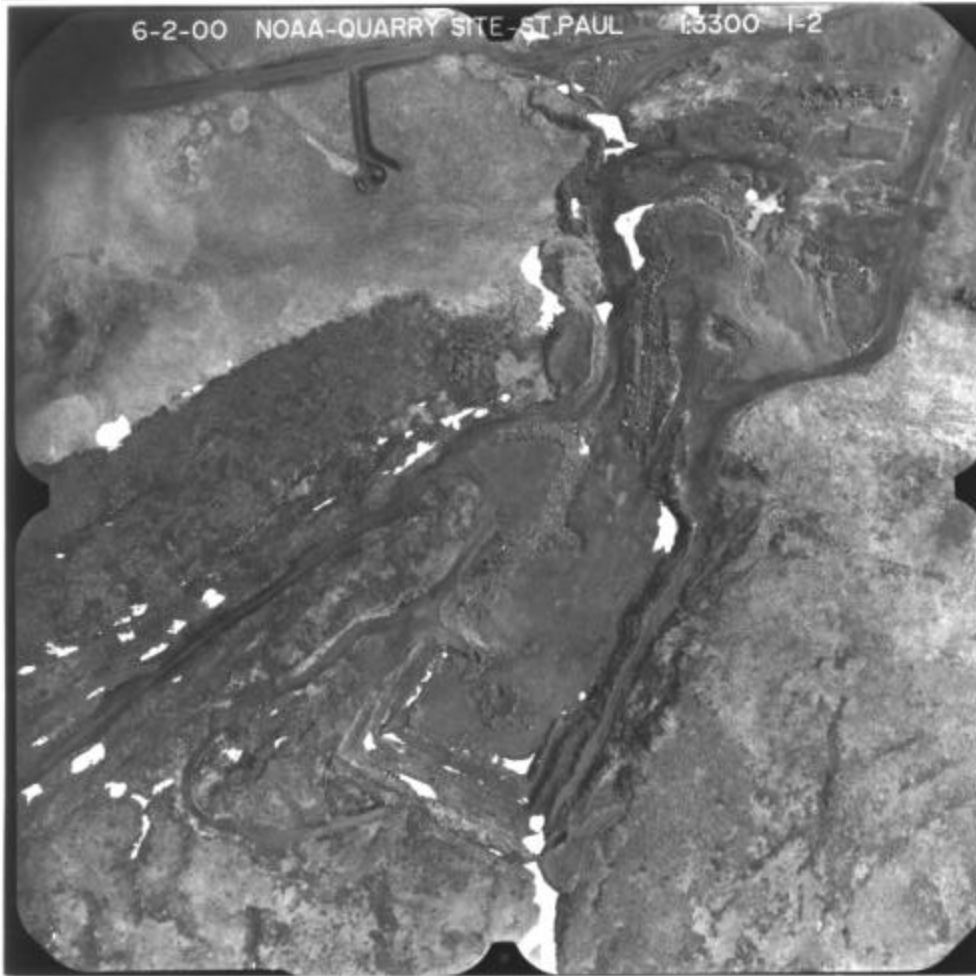
Photo 7. Telegraph Hill Quarry (Tract 37). Aerial Photograph. Note Image is Oriented with Due North at 9 O'Clock. Aeromap. 2000.
